Debris/Ice/TPS Assessment and Integrated Photographic Analysis of Shuttle mission STS-105

**DEBRIS/ICE/TPS ASSESSMENT and
INTEGRATED PHOTOGRAPHIC ANALYSIS
OF SHUTTLE MISSION STS-105**

Armando Oliu
Process Engineering/Mechanical System Division/ET-SRB Branch,
Kennedy Space Center, Florida

August 10, 2001

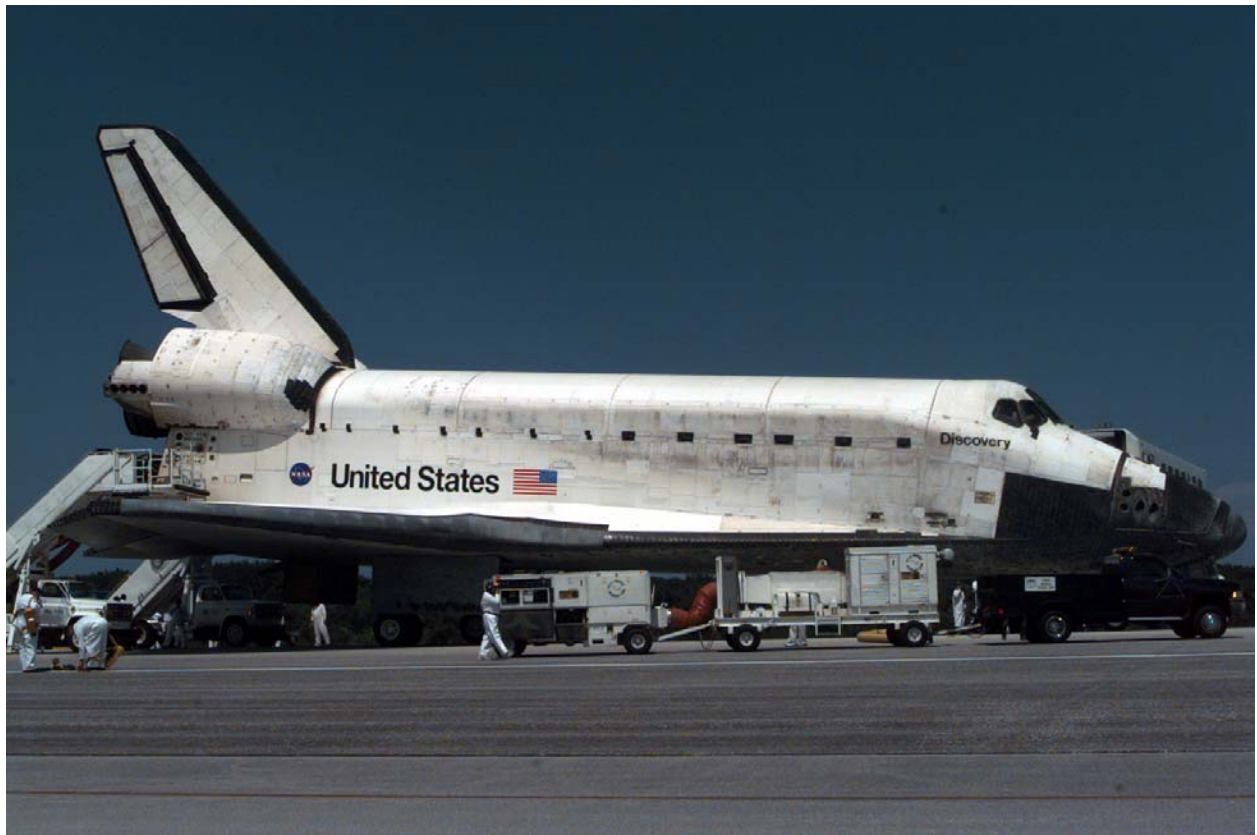
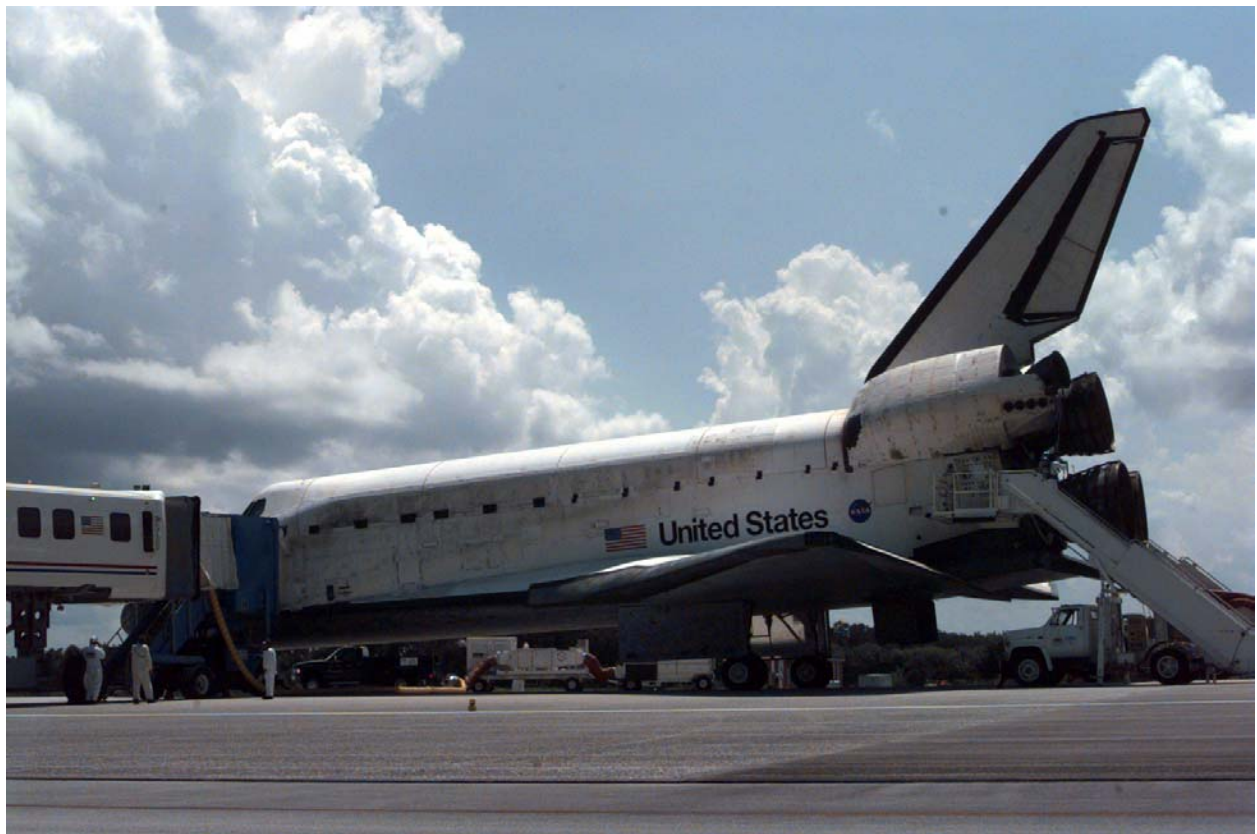
Photo 14: Overall View of Orbiter sides

The orbiter lower surface sustained 108 total hits, with 15 having a dimension greater than 1-inch. Both the total number of Orbiter TPS debris hits and the number of hits 1-inch or larger were within established family.

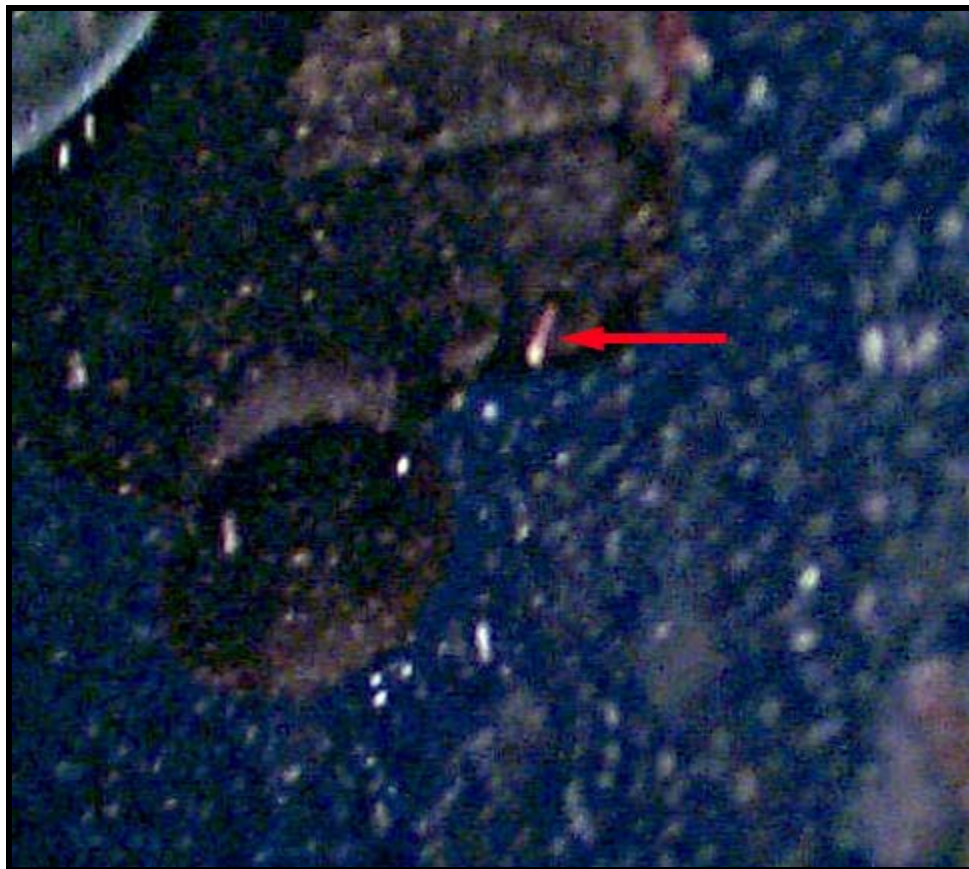
Figure 2.1 Cylindrical-Shaped Debris During Liftoff (Camera E18)

An unidentified, thin, cylindrical-shaped, rigid-appearing, piece of debris was seen falling from near the LH2 TSM T-0 umbilical disconnect and past the left RCS stinger 1.5 seconds after

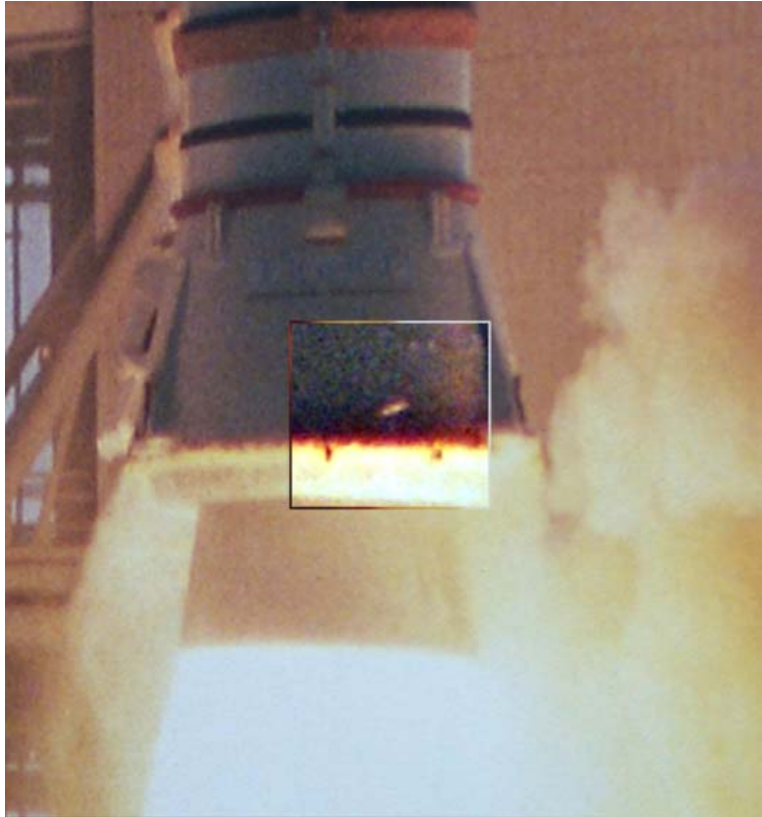
Figure 2.2.1 (B) Debris Near RSRB Aft Skirt During Liftoff (Camera E52)

A small piece of debris was seen near the RSRB aft skirt during liftoff on camera E52 (21:10:15.600 UTC). On the camera E4 film, a piece of debris was seen arcing upward from the RSRB aft skirt area toward the ET aft dome at liftoff. Also on camera E4, a second piece of debris was seen arcing upward from the LSRB aft skirt area toward the ET aft dome at liftoff. None of these debris were seen to contact the launch vehicle. (Cameras E1, E4, E52)

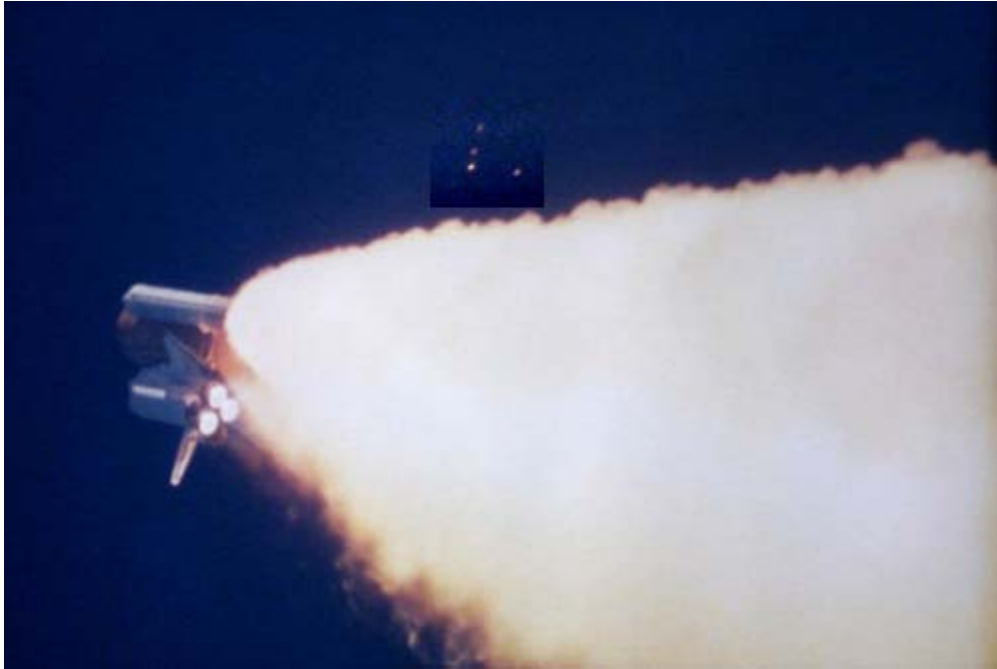
Figure 2.2.2(A) Debris Spray Seen Exiting the SRB Exhaust Plume (Camera E223)

As on previous missions, debris was seen exiting the SRB exhaust plumes. The debris exiting the SRB exhaust plumes during the majority of the ascent was probably instafoam from the aft end of the SRB's. The more dense appearing debris near the time of tail-off, just prior to SRB separation, was probably SRB slag debris. Examples of this debris can be seen in Table 2.2.2 (B).

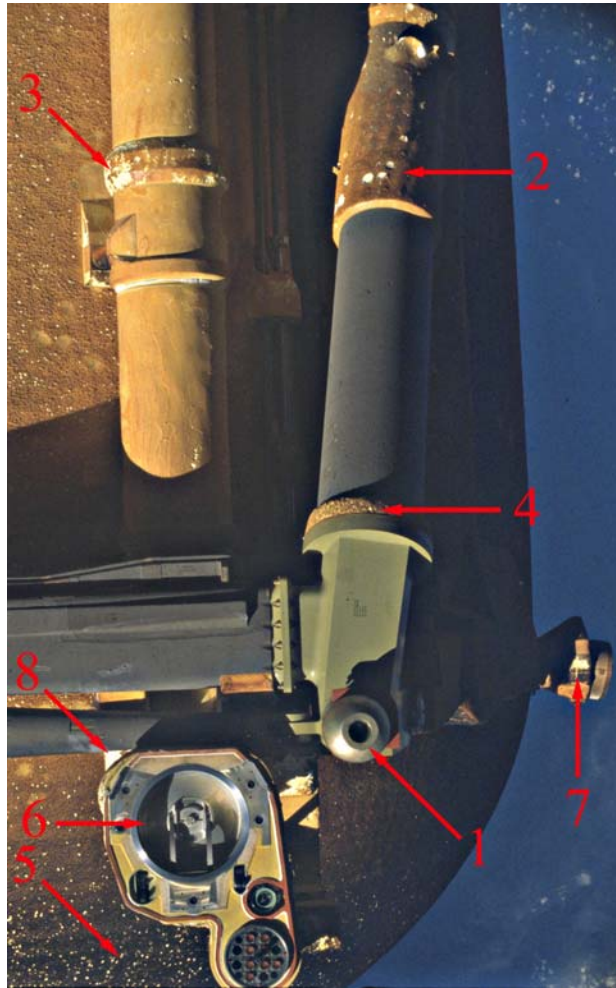
Figure 2.3.2 (A) View of the Aft ET (frame 10)

The separation bolt between the ET and the aft end of the Orbiter (EO-3 fitting near the liquid oxygen umbilical) was observed to be retracted and not protruding. See Figure 2.3.2 (A), annotation 1. (The EO-3 bolt was seen to be protruding on STS-106, STS-102, and STS-100 umbilical well camera films. A Shuttle Program investigation of the STS-106 bolt extension was previously conducted in October, 2000).

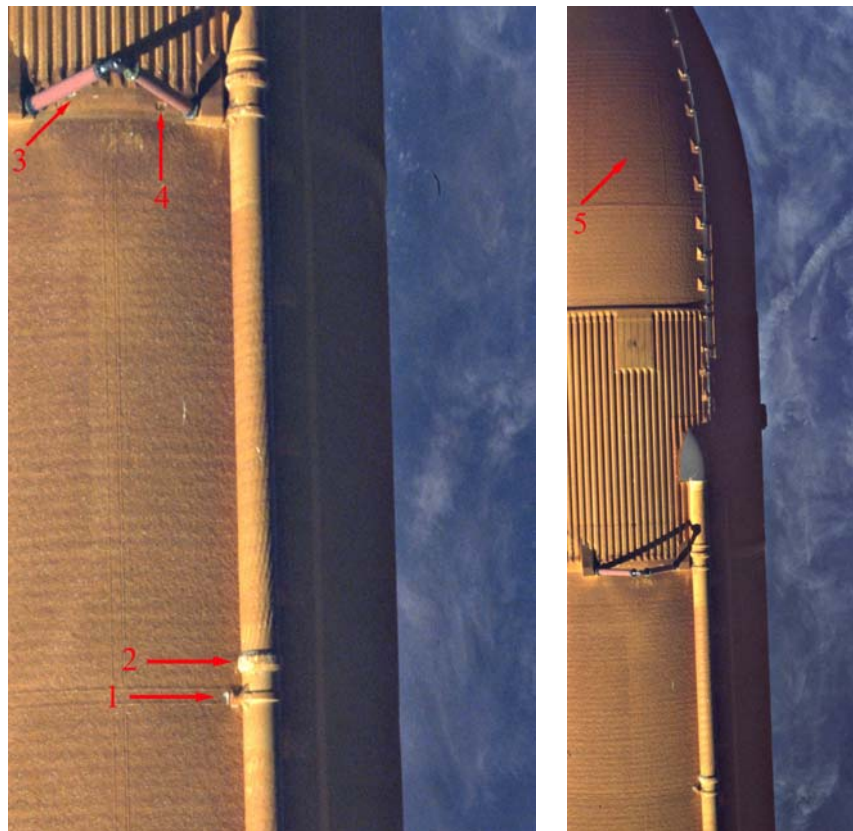
Figure 2.3.2 (B) Views of the Forward ET (frames 45 and 58)

As typically seen, multiple very small “popcorn” divots were seen on the LH2 tank TPS forward of the ET crossbeam.

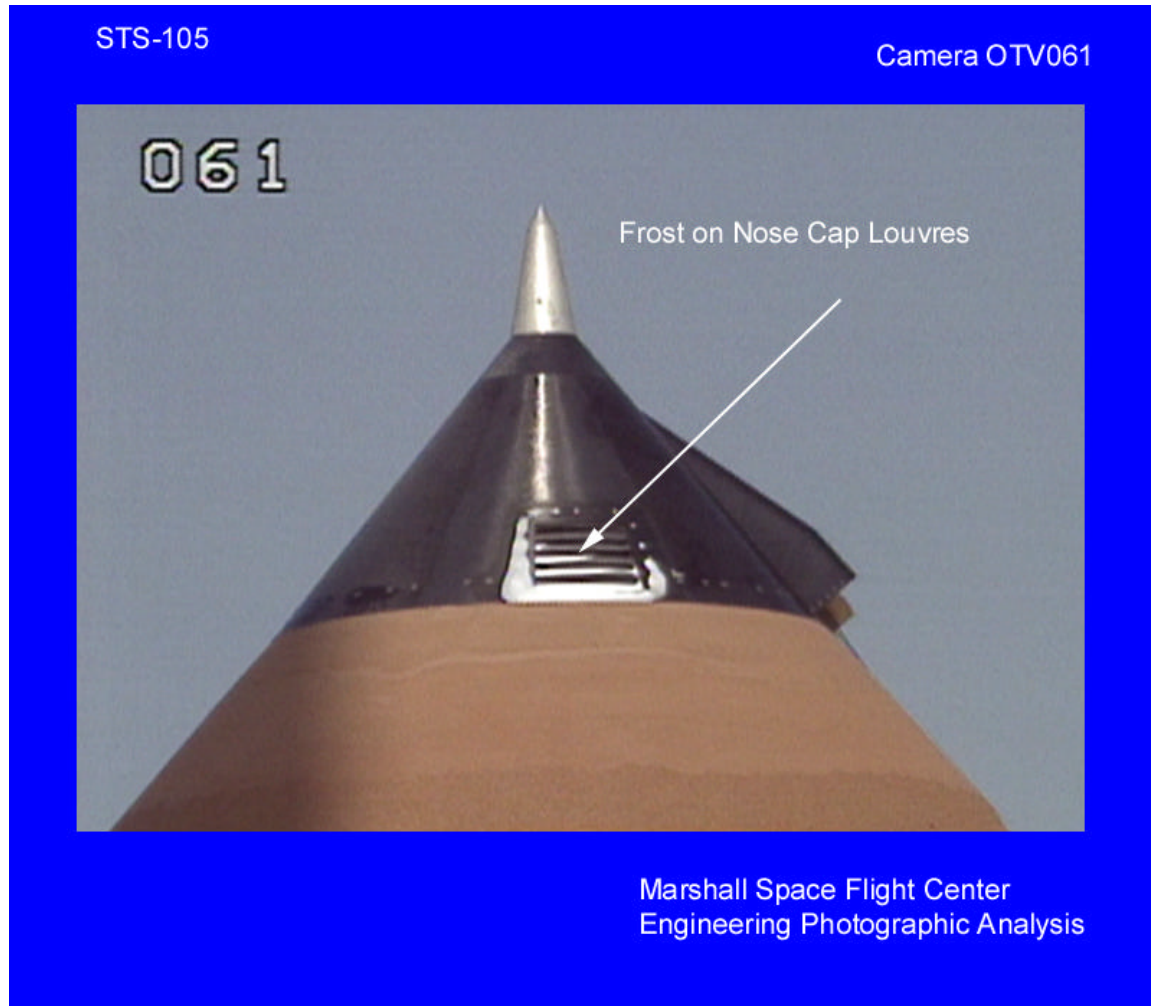
Figure 1. Frost on ET Nose Cap Louvers

Frost was observed on the External Tank Nose Cap Louvers prior to liftoff.

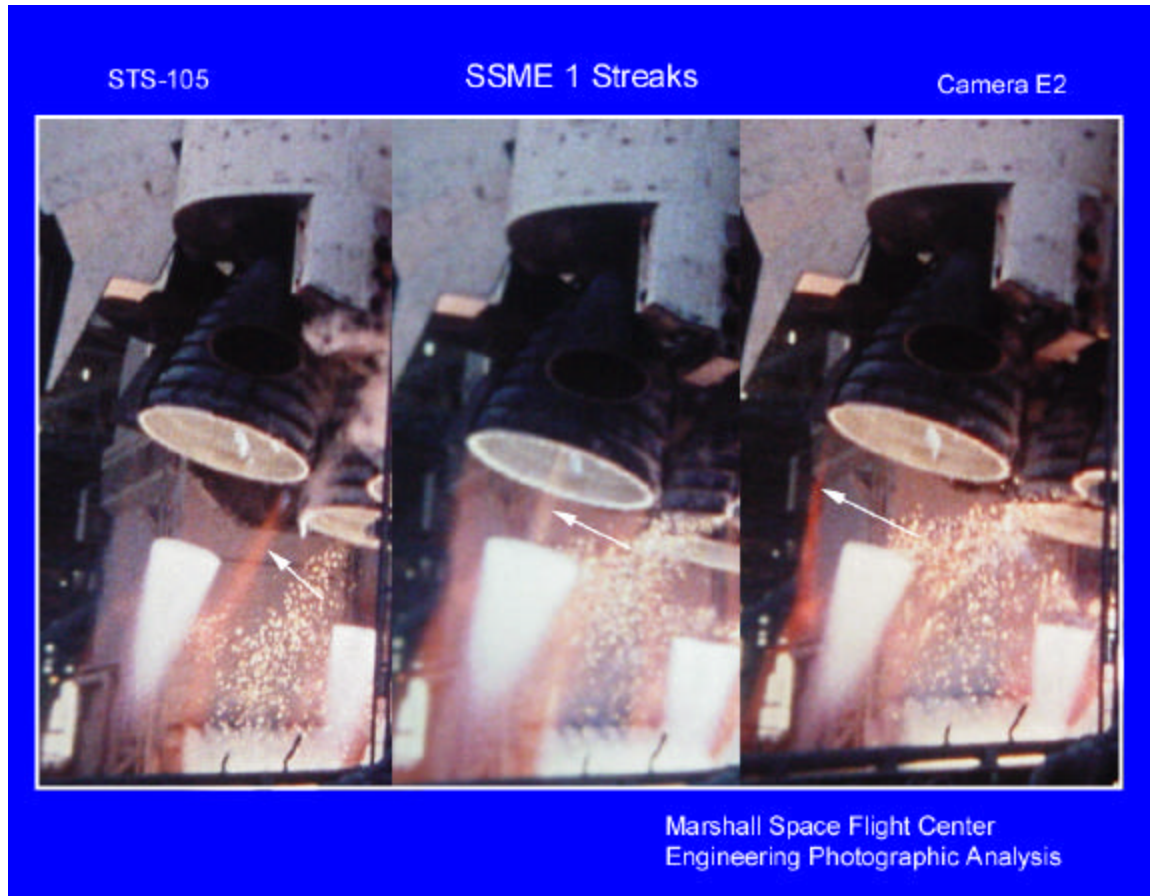
Figure 2. Streaks in SSME #1 Plumes

Several engine streaks were observed in SSME#1 plume prior to launch. Timing for these streaks: 222:21:10:11.296 UTC, 222:21:10:12.514 UTC, 222:21:10:13.140 UTC and 222:21:10:14.728 UTC. The duration of the streaks was approximately one frame or 1/400 sec. Engine streaks of this short duration are common occurrences, seen on many previous missions.

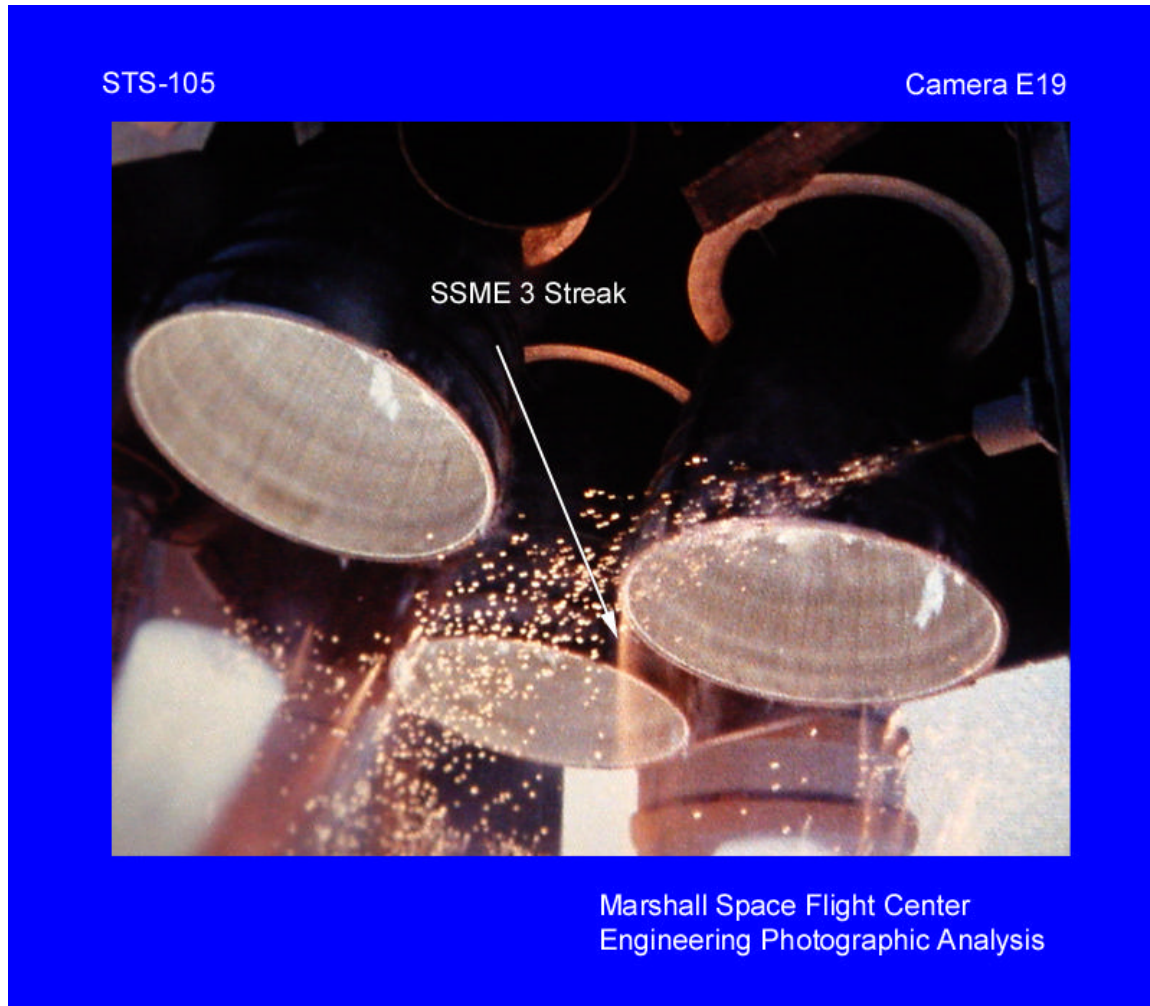
Figure 3. Streaks in SSME #3 Plumes

Several streaks were also observed in SSME#3 plumes prior to launch. Timing for these streaks: 222:21:10:12.078 UTC, and 222:21:10:13.380 UTC.

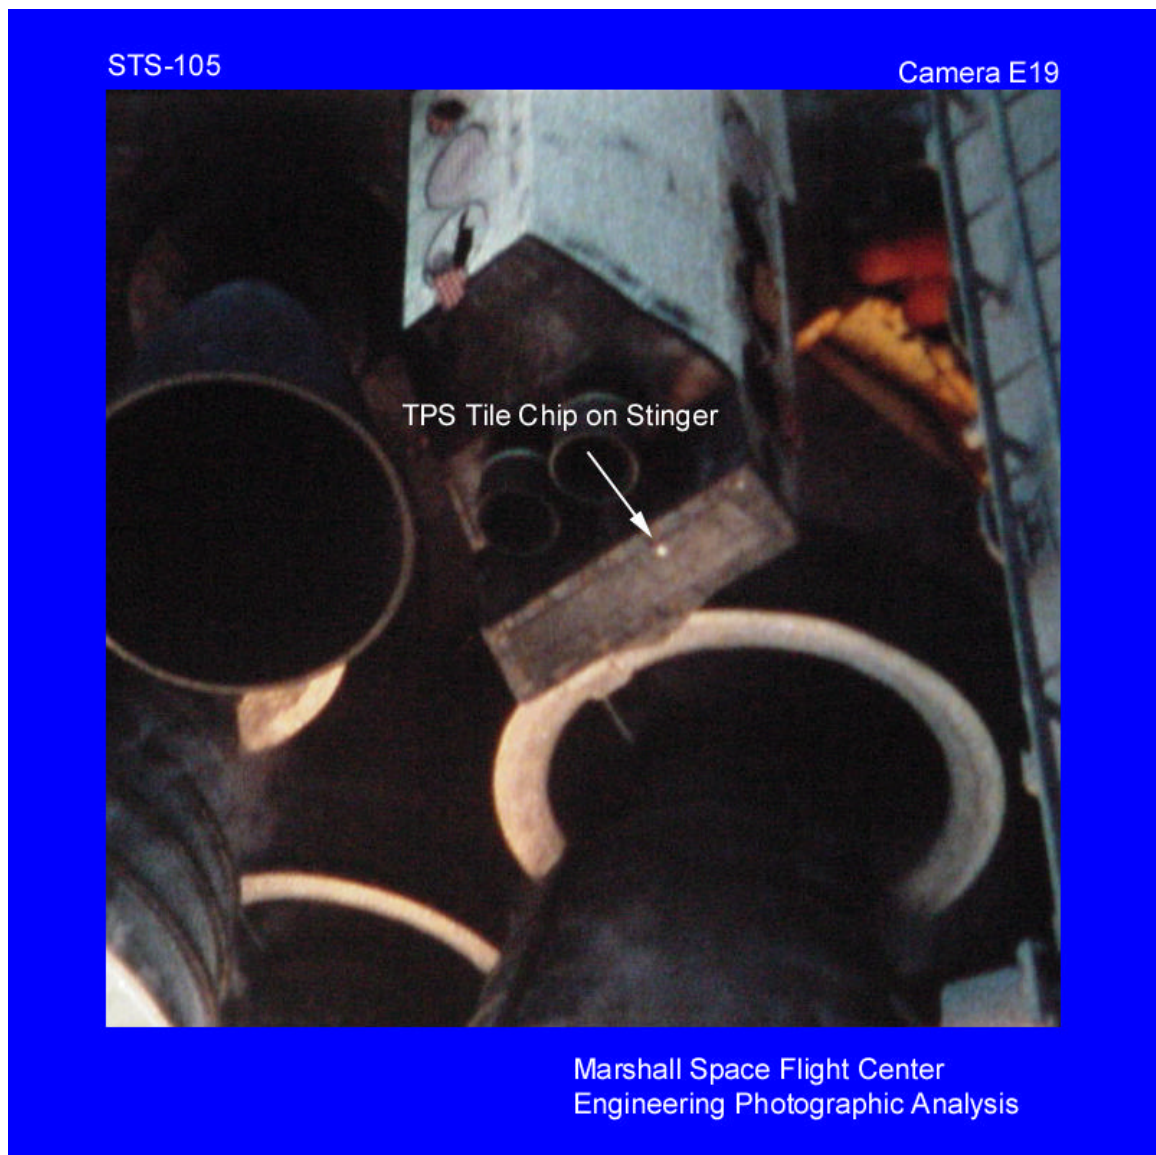
Figure 4. Chipped Tile on Right Stinger Pod

A chipped tile was observed on the Right Stinger Pod.

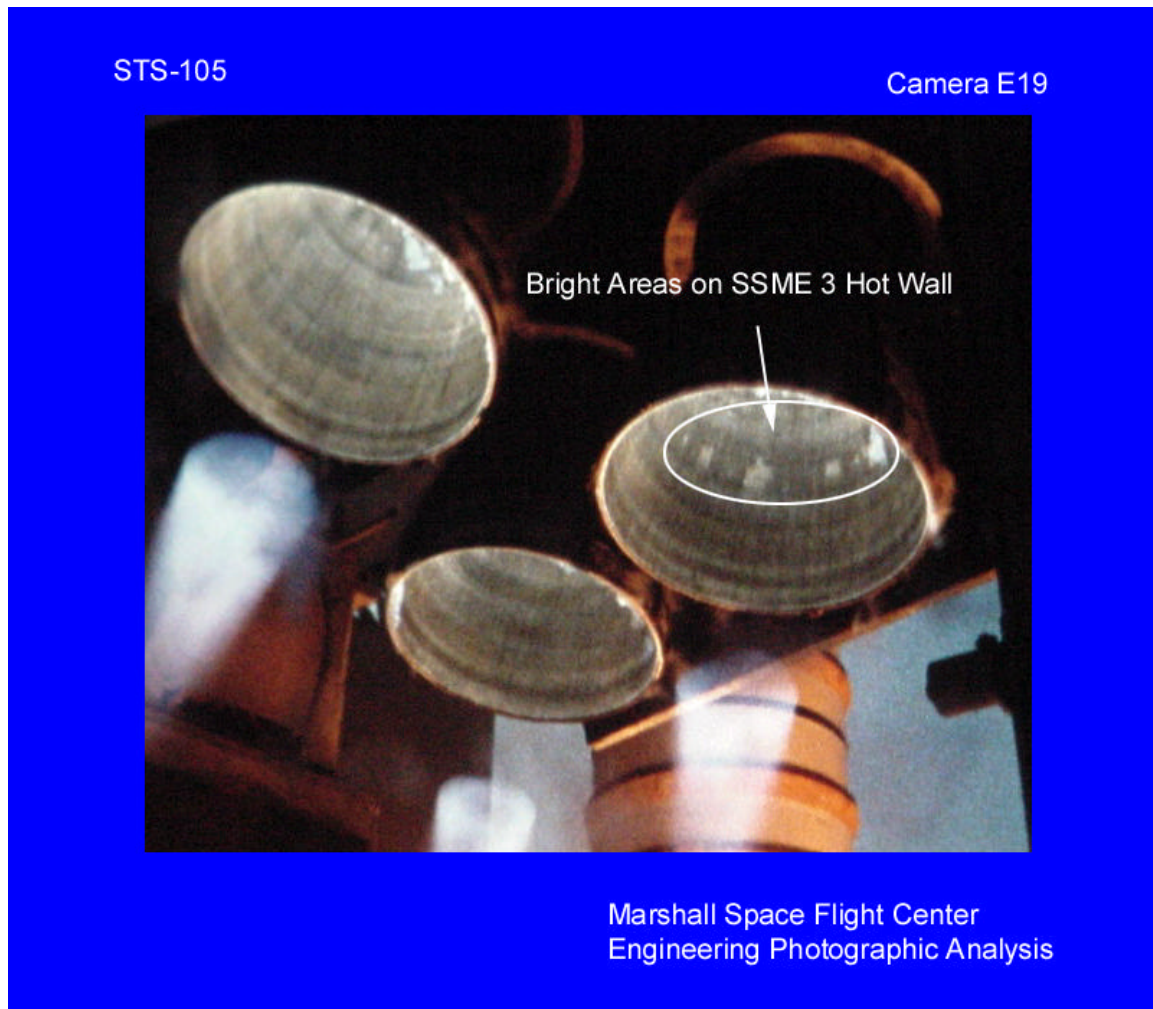
Figure 5. Bright Areas on SSME#3 Hot Wall

Several bright areas were observed on the hot wall of SSME #3 nozzle. Bright areas on SSME hot walls have been observed previously.

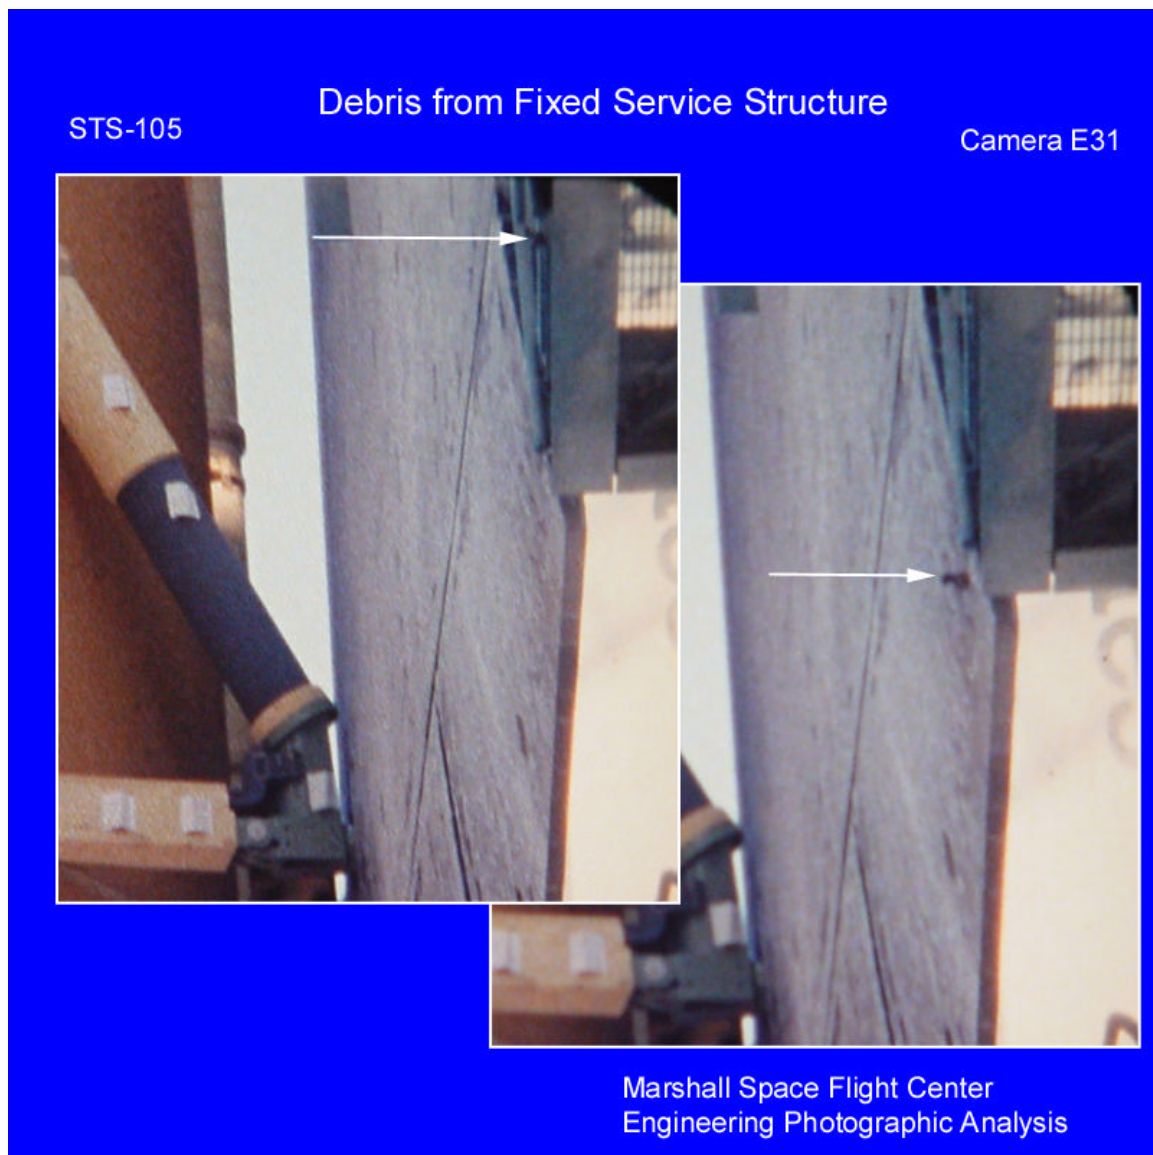
Figure 6. Dark-colored debris Falls from FSS prior to Liftoff

Dark colored debris fell from the Fixed Service Structure prior to Liftoff.

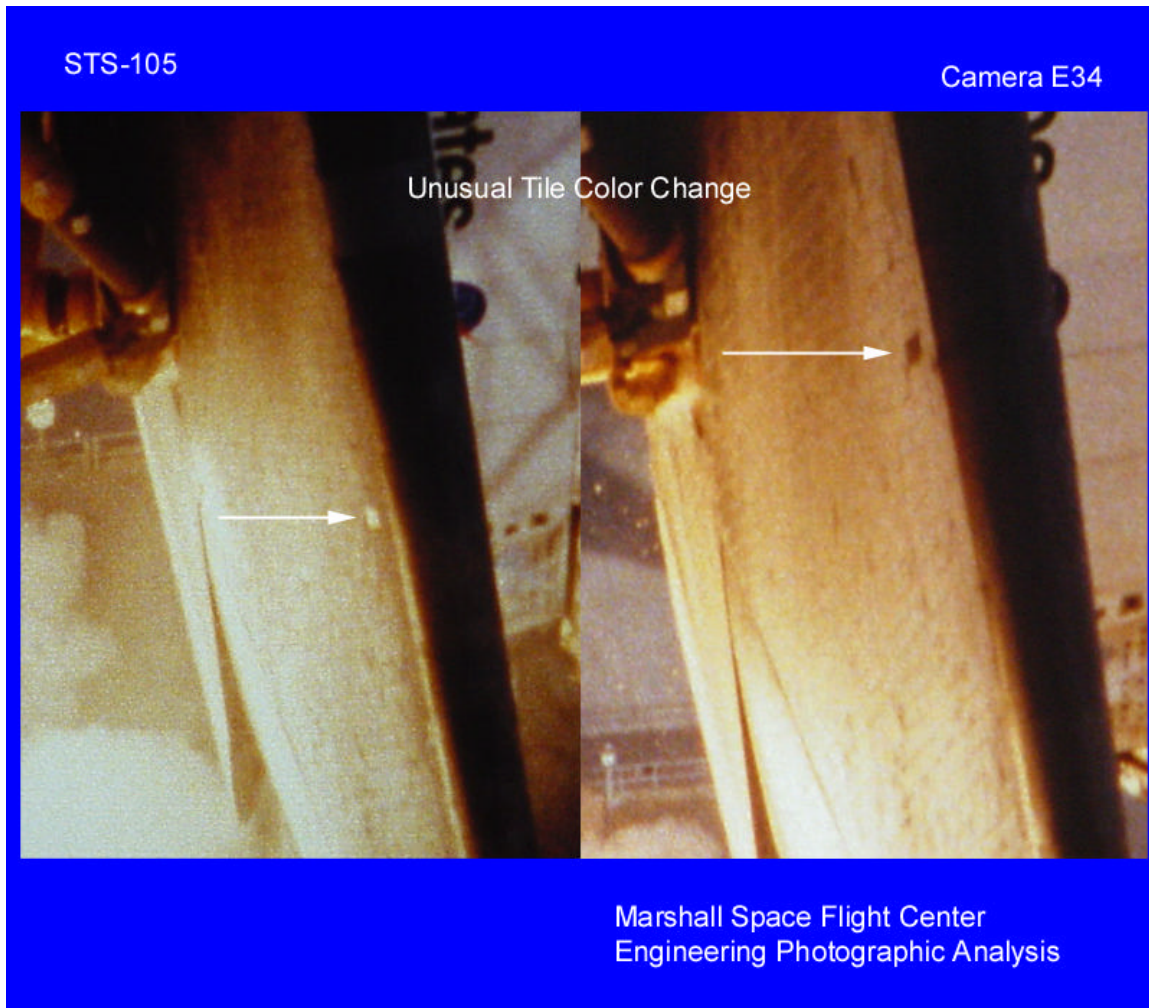
Figure 7. Orbiter Tile Coloration Change

A tile on the -Z side of the left Orbiter wing appeared to change coloration, most likely from lighting changes on the tile as the Orbiter lifts off the pad. This coloration change is considered noteworthy

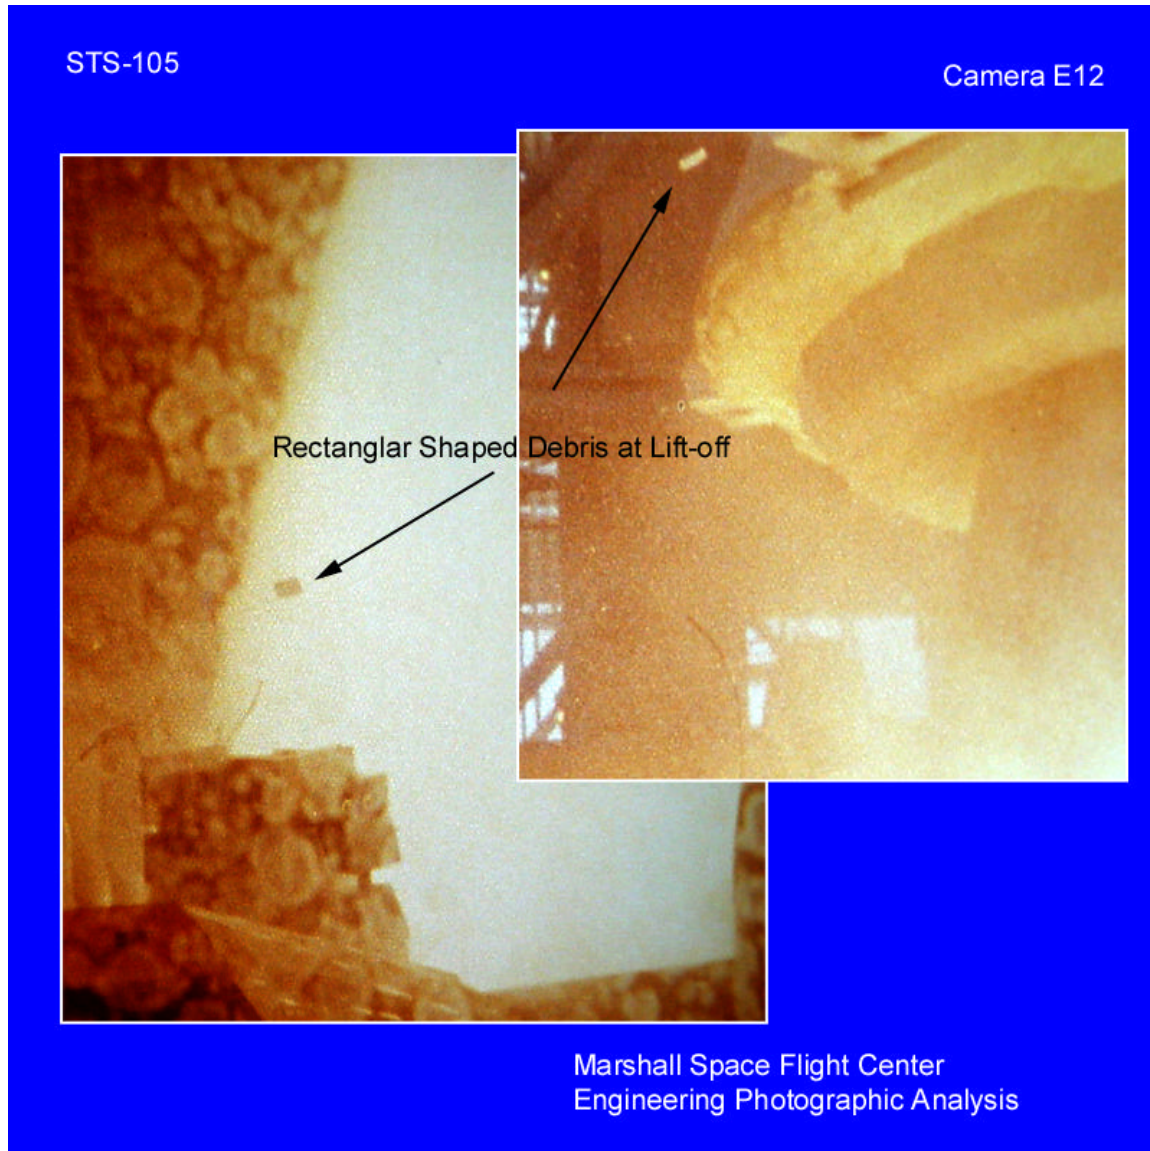
Figure 8. Rectangular Shaped Debris near SRB at Liftoff

A rectangular shaped debris object was noted in the vicinity of the SRB aft skirt at liftoff. Film camera E12 view SRB Holddown Post M-5 during ignition and liftoff.

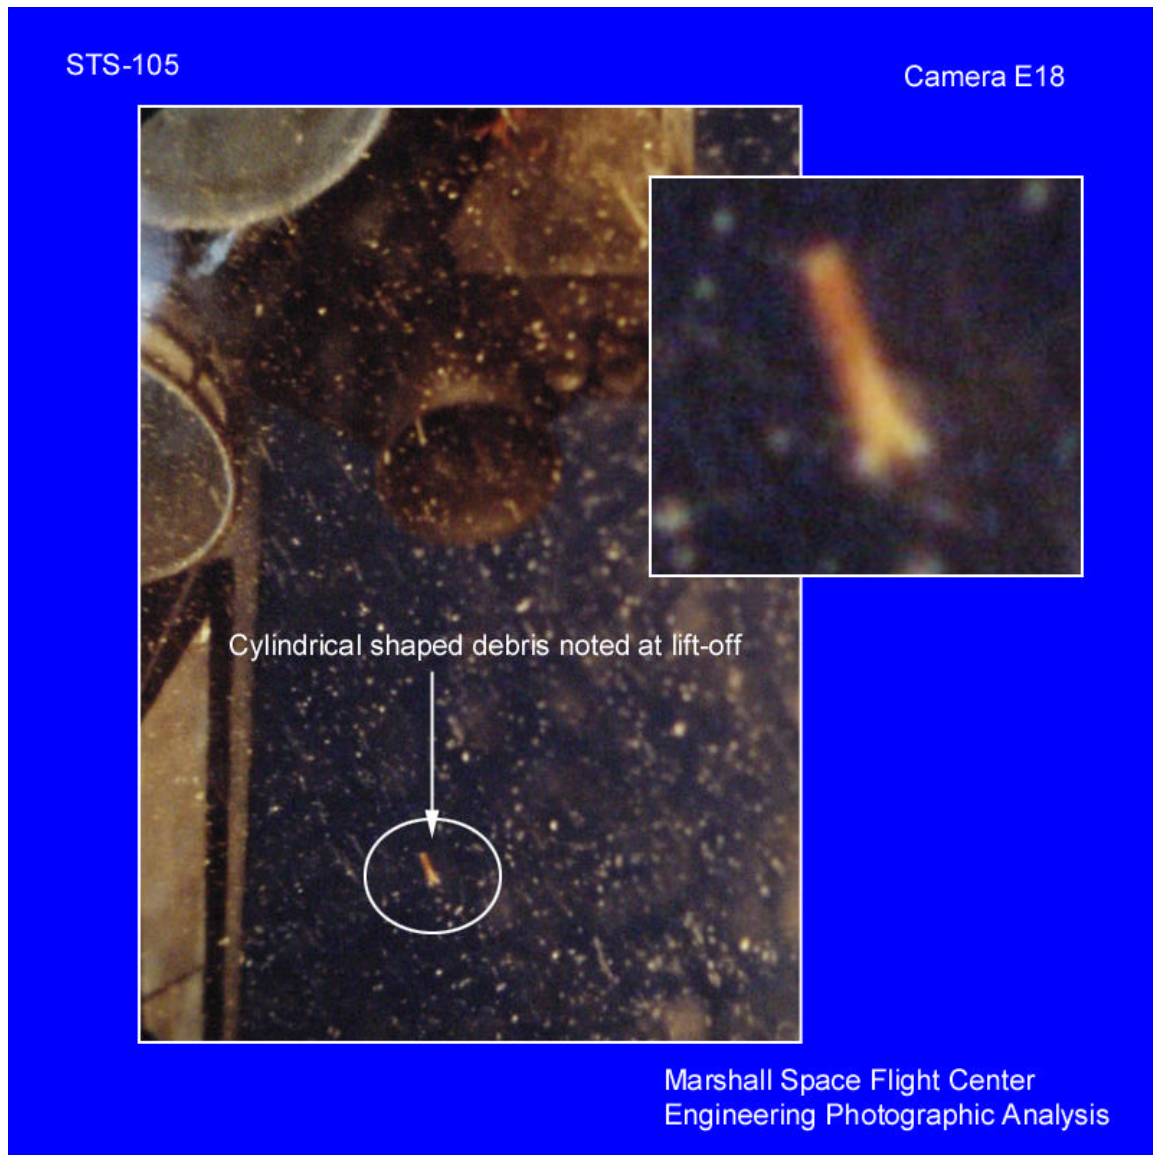
Figure 9. Cylindrical Debris Item

This observation was listed in the STS-105 Launch+4 Day "CONSOLIDATED FILM REVIEW REPORT" by the KSC, JSC, MSFC Film/Video Analysis Teams released on 15 August 2001.

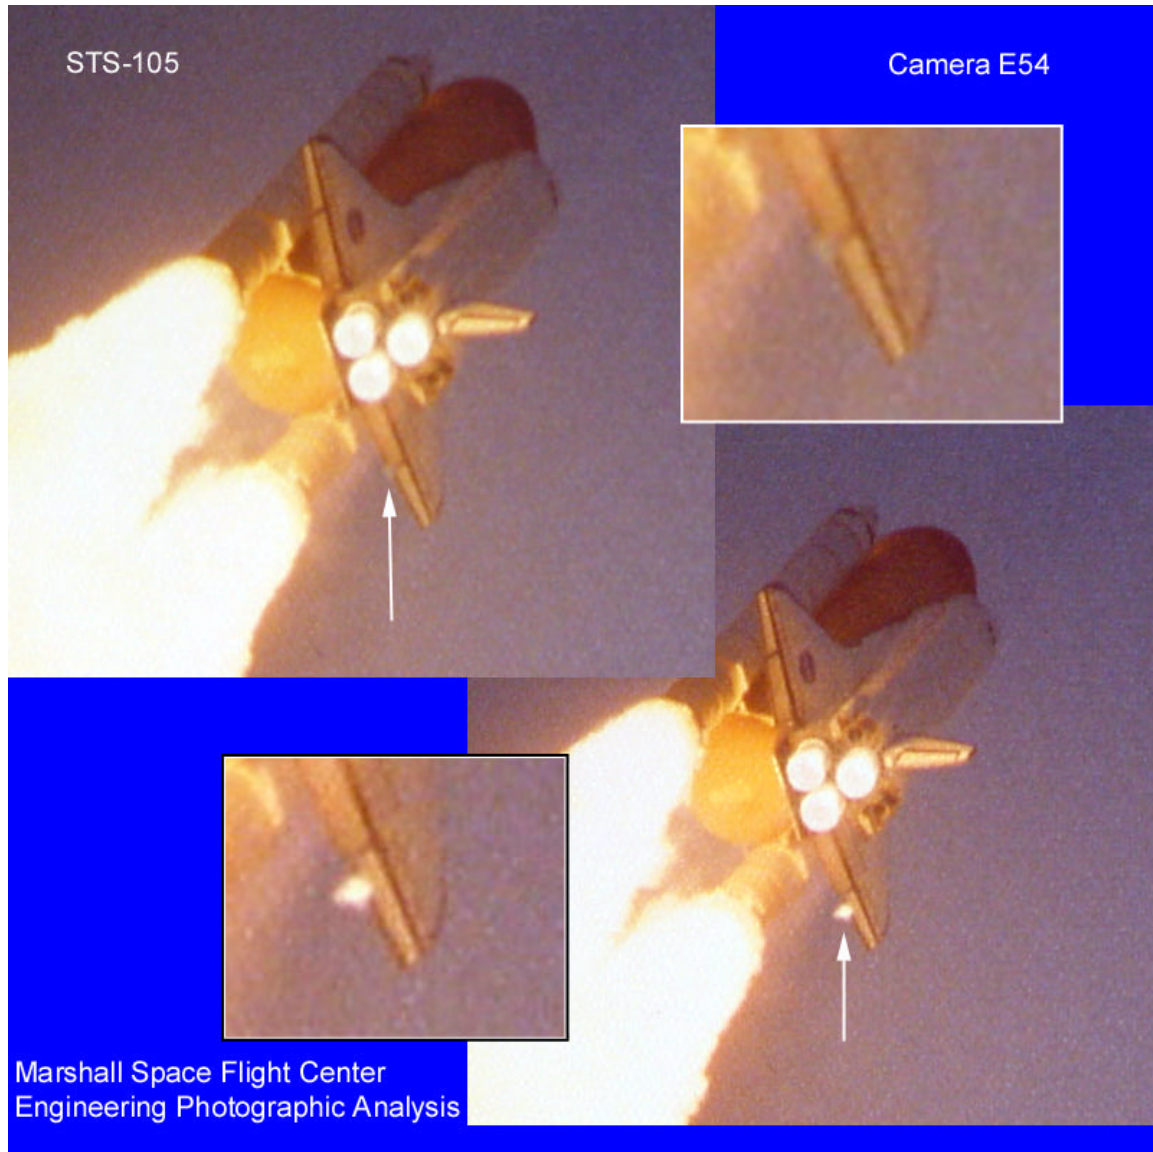
Figure 10. Bright Object near Right Wing of Orbiter

A bright object was noted near the right wing of the Orbiter during ascent. A small gray-colored object is noted on the inserts, from the frame just prior to the change in illumination in the object and in approximately the same location.

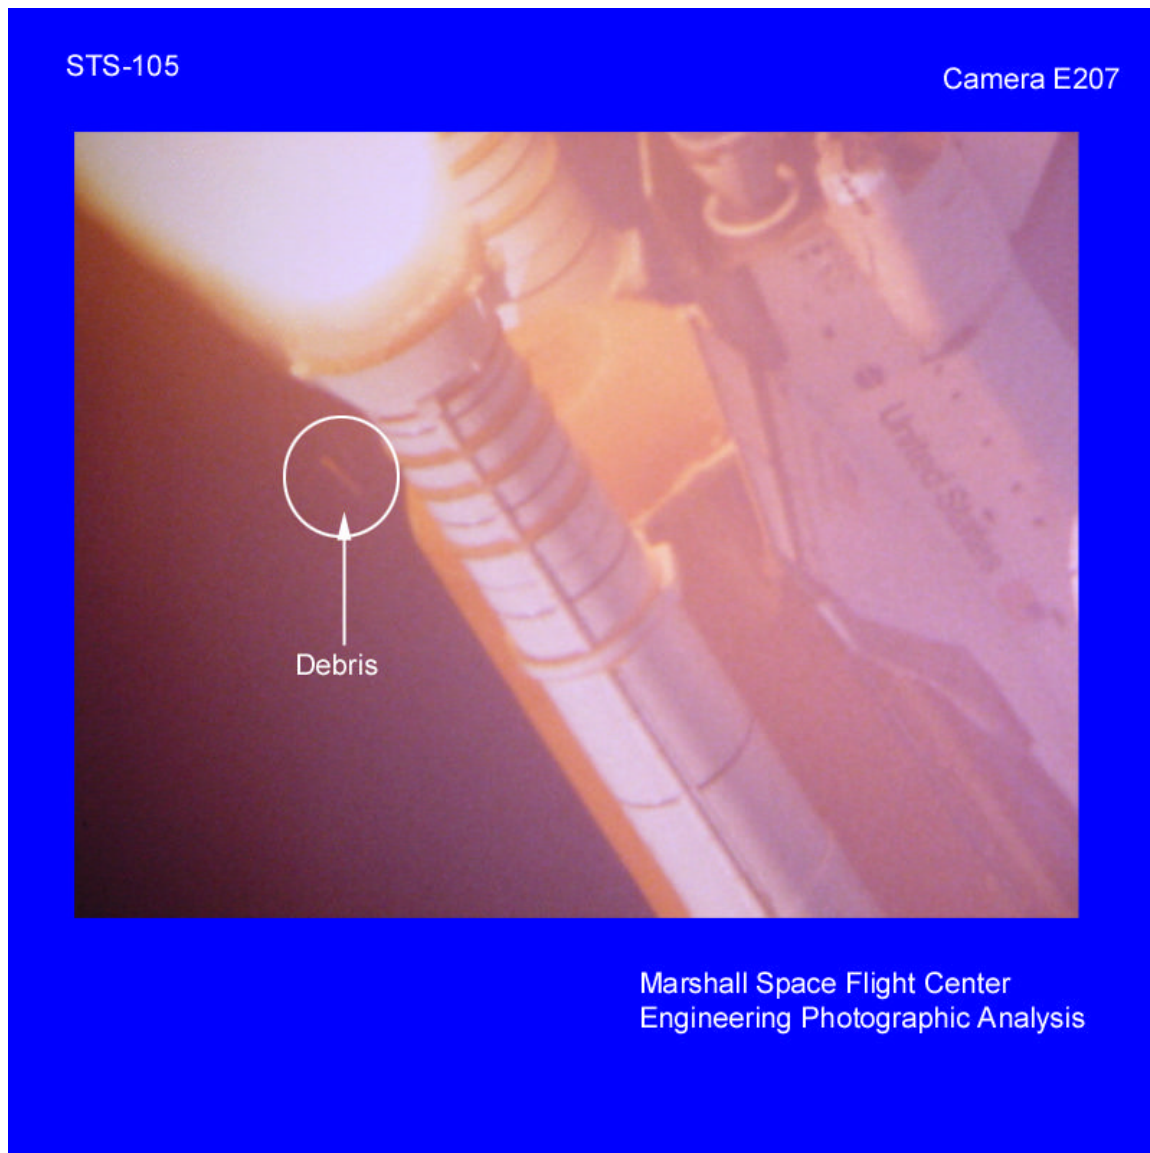
Figure 11. Camera E-207: Brown-colored Debris on -Z Side of Vehicle

Brown-colored debris was observed, by film camera E-207 ,on the -Z side falling away from the vehicle during ascent.

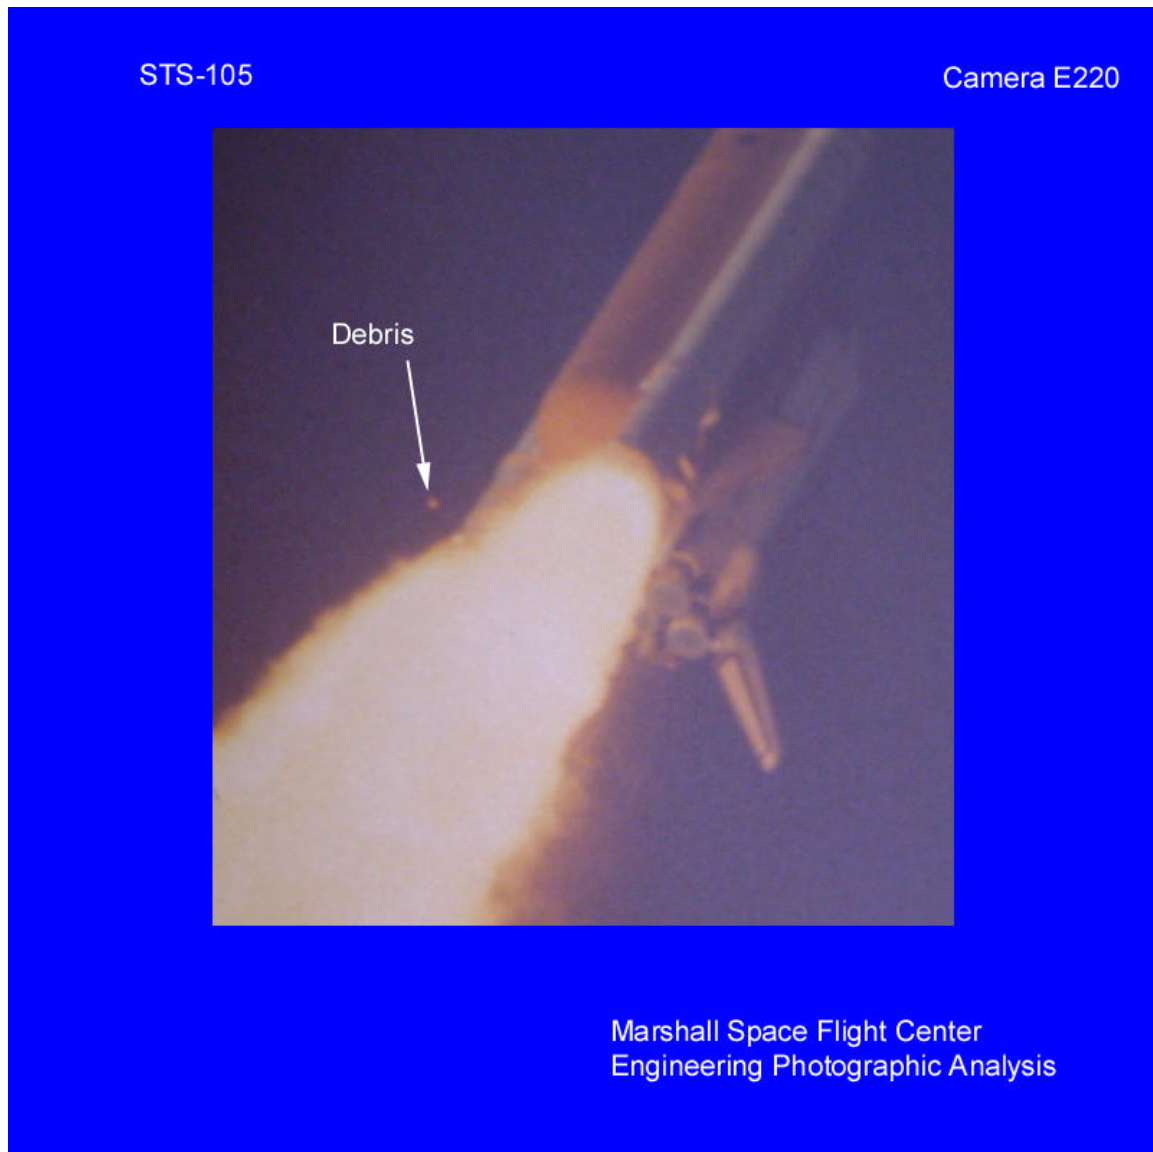
Figure 12. Camera E220: Brown-colored Debris on -Z Side of Vehicle

The debris in this image was observed by film camera E220. It is likely the same debris as that observed by film camera E-207 in Figure 11, on the -Z side falling away from the vehicle during ascent.

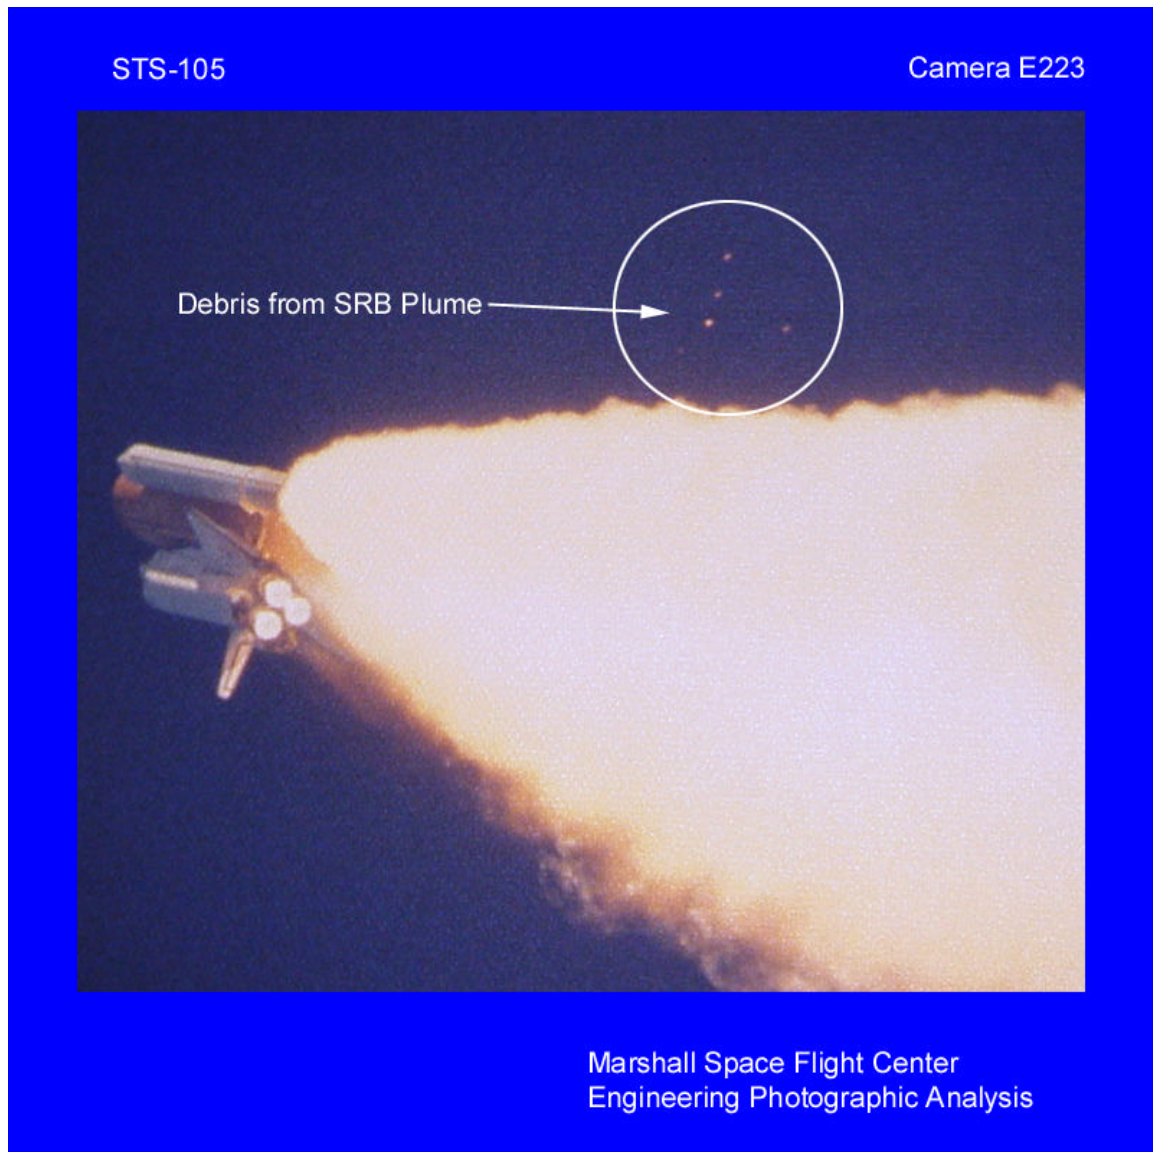
Figure 13. Debris Ejected from SRB Plumes

Numerous pieces of debris were noted, from Film camera E223, as they were ejected from the SRB plumes. This event occurred at approximately 222:21:11:22.305 UTC.
